Property Inspection Report

50.84 Acres Raw Land		
Parcel #: 5		D

Completed by: Scott D. Walter Mid-Atlantic Drone Services LLC

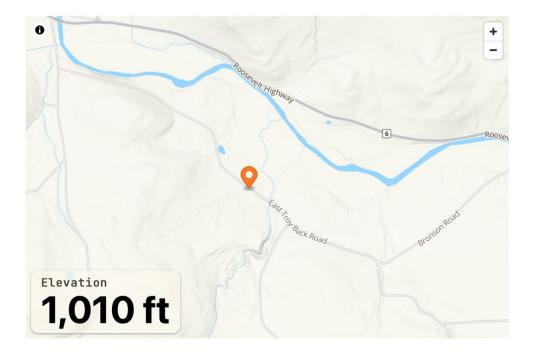
At the access point, the property is approximately 1,000 FT in elevation. The elevation increases gradually as one proceeds WSW, across the clearings and back to the power lines and wooded area. The top elevation is estimated to be approximately 1,250 ft, near the WSW boundary.
